IMAGES IN CARDIOLOGY

Right Bundle Branch Block Pattern During Right Ventricular Pacing: Inadvertent Pacing Lead Placement or a False Alarm? / Just a Need for a Lower Relocation of V1/2 ECG Lead Placement!

A case of right bundle branch block pattern of right ventricular pacing is presented wherein a simple maneuver of precordial V1/2 ECG lead relocation clarified the problem. *Rhythmios 2020; 15(2):33-34.*

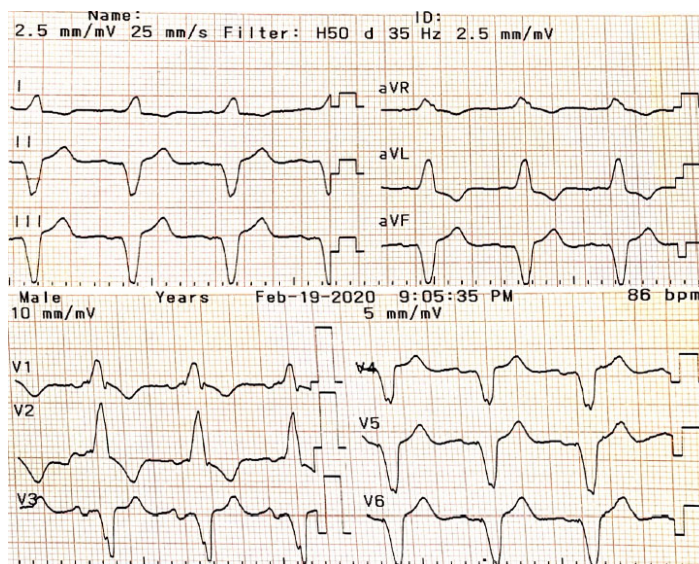
Figure 1

An 89-year-old lady was seen at the office for a routine visit for a pacemaker check. All pacing and sensing parameters were within normal limits. However, when a 12-lead electrocardiogram (ECG) was obtained by our nurse (**Fig. 1**), there was concern about the appearance of lead V1, which showed a right bundle branch block (RBBB) morphology of the paced QRS complex. Right ventricular (RV) pacing should have been reflected by a left bundle branch block (LBBB) pattern on the ECG.

As there was no reason to suspect a misplaced or displaced pacing lead, a repeat ECG was obtained with the V1/2 leads placed at the 4th intercostal space (ICS) and this recording was consistent with RV pacing showing an LBBB pattern (**Fig. 2**). The nurse who performed the initial ECG was asked about the position of the V1/2 leads and she indicated that these had been placed “a bit” higher, actually at the 2nd ICS. Then a repeat ECG was obtained with the V1/2 leads placed at the 2nd ICS confirming the RBBB pattern obtained with the initial ECG (**Fig. 3**).
